FSN Ref: R2021-02

Urgent Field Safety Notice

Cemento Mini Set for Cemento-MP

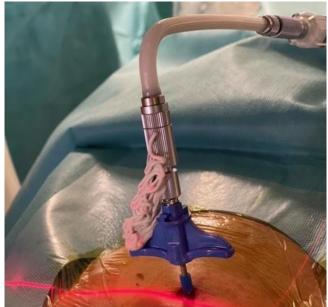
-	occurred at the distal luer lock of the connection hose (see fig. 2)		
2	2. Hazard giving rise to the FSCA		
-	We have been informed about 4 cases with cement leakage; none of the patients has been harmed. The user can clearly see the leakage of the cement because it happens outside the patient. When the user notices a leakage, he must use a new set. Since the cement cannot be applied into the patient in case of a leakage, there is no risk to the patient. We decided to recall the affected products, because the malfunction is not		
	acceptable, even if there is no risk for the patients.		
2	3. Probability of problem arising		
	There are four lots which may be affected by this leakage. 697 mini sets of these four lots has been delivered by optimed, and four cases of leakage has been reported. The complaint rate is 0.57%.		
2	4. Predicted risk to patient/users		
	According to the available information, there is no risk for patients.

2	5. Further information to help characterise the problem		
	n/a		
2	6. Background on Issue		
	The root cause was identified as a deviation in the tolerance during production of the		
	rotatable Luer lock connection. Only products of the 4 above-mentioned lots can be affected by this manufacturing defect. Other lots are not affected by this possible defect.		
2	7. Other information relevant to FSCA		
	Other lots of this part number and other products are not affected.

Fig. 2: Leakage at distal Luer Lock of the connection hose

3.	. Type of Action	to mitigate	the risk
3.	1.	Action To Be Taker	n by the User		
		\boxtimes Identify Device \boxtimes C	Quarantine Device	⊠ Return Devi	ce
		On-site device modific	ation/inspection		
		□ Follow patient management recommendations			
		\Box Take note of amendment/reinforcement of Instructions For Use (IFU)			
		□ Other □ N	None		
		The affected products should return all products of the affe	•	ents. Quarantine all	affected products and
3.	2.	By when should the action be completed?	As soon	n as possible	
3.	3.	Particular consideration	ns for: n/a C	hoose an item.	
		Is follow-up of patients	or review of patients' p	previous results	recommended?
		No			
3.	4. (If y	Is customer Reply Req yes, form attached spec		rn)	Yes

3.	5.	5. Action Being Taken by the Manufacturer		
			 On-site device modification/inspective IFU or labelling change None 	ection
		All affected products are separated at optimed and will be exchanged.		
3	6.	By when should the action be completed?	As soon as possible	
3.	7.	Is the FSN required to be communicated to the patient No /lay user?		
3	8.	If yes, has manufacturer provided additional information suitable for the patient/lay user in a patient/lay or non-professional user information letter/sheet?		
		n/a Choose an item.	Choose an item.
