FSN Ref: R2021-02

Urgent Field Safety Notice

Cemento Mini Set for Cemento-MP

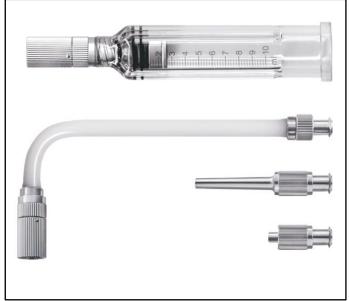
Fig. 1: Optimed Cemento Mini Set for Cemento-MP

1. Information on Affected Devices*		
1.	1. Device Type(s)			
	Cemento Mini Set for Cemento-MP: complementary set with injection cylinder,			
	connection hose, aspiration cannula, and Luer Lock adapter (see fig. 1 above)			
1. 2. Commercial name(s)				
	Cemer	nto Mini Set for Cemento-MP		
1.	3.	Unique Device Identifier(s) (UDI-DI)		
	n/a			
1.	4.	Primary clinical purpose of device(s)		
	The op	timed Cemento MP is an injection system for cemetoplasty / vertebroplasty.		
1.	1. 5. Device Model/Catalogue/part number(s)			
	1382-0	100		
1.	6.	Software version		
	n/a			
1.	7.	Affected serial or lot number range		
	13622	13661, 13712, 13822		
1.	8.	Associated devices		
	n/a
